# Geared Up For Another 37 Years

Peter Wenzinger,  
FLSmidth MAAG Gear AG,  
Switzerland, demonstrates  
how professional  
maintenance and  
service can pay off with  
this case study from  
Holcim Untervaz.

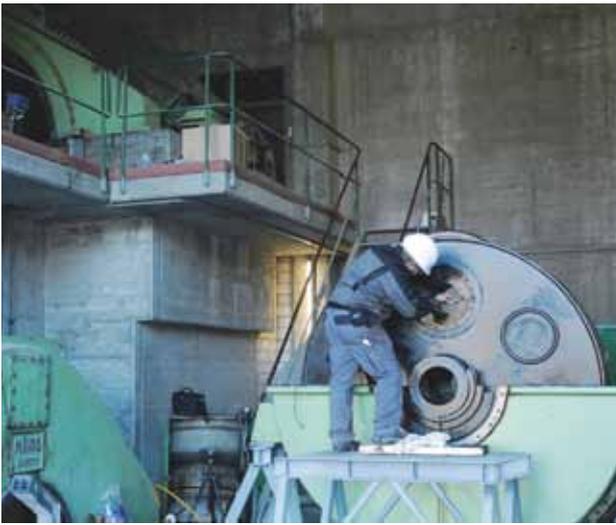
Figure 1. First general onsite inspection of FLSmidth MAAG Gear's Planetary Gearbox P2U3 after 37 years and approximately 200 000 h of operation (first stage).

The first and second stages were disassembled completely. The first stage was found in a good general condition as described in detail below. Only the bearings and axles had to be replaced due to normal wear. The new bearings have been equipped with temperature sensors for more operation data and safety in the future. Fortunately, all required spare parts were on stock at the plant.

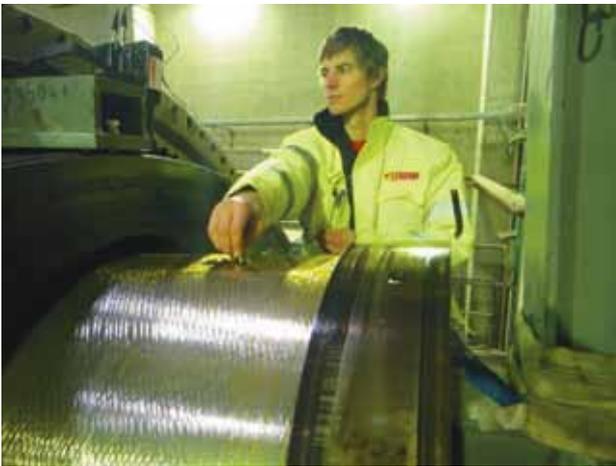
Figure 2. Ultrasonic examinations/tests (UT).

External specialists using special testing equipment inspected all the toothed parts, such as sun pinions, annulus, planet wheels, planet axles, internal coupling, as well as the planet carrier. Dye penetration tests (PT), fluorescent magnaflux tests (MT) and ultrasonic examinations (UT) were carried out. PT and MT are generally used to check the surfaces for cracks (e.g. tooth flanks or white metal on bearings). Even micro cracks can be detected by these tests. UT is used to check the parts for invisible damages under the surface (e.g. toothing or planet axles), as shown in Figure 2.

their good condition. This speaks for the quality of materials used, quality and accuracy of the production line, and the quality of adherence to MAAG standards. The planet axles were also checked by UT and by PT. All the second stage axles were in good condition and will be used for further operation, with only the first stage axles needing replacement.

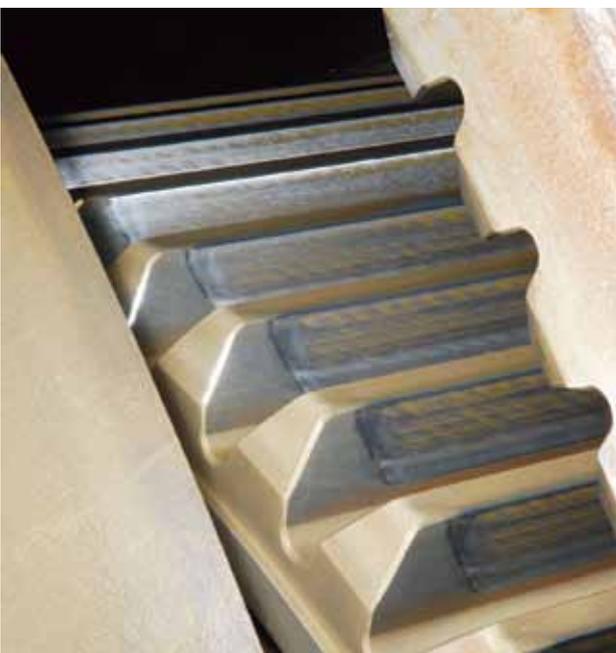
Figure 3. Original surface pattern still visible on the planet wheels of the second stage.

All toothings were found to be without any damage. On some gears, even the surface pattern originating from the manufacture, was still visible (Figure 3). The toothing specialists also inspected the parts visually and confirmed

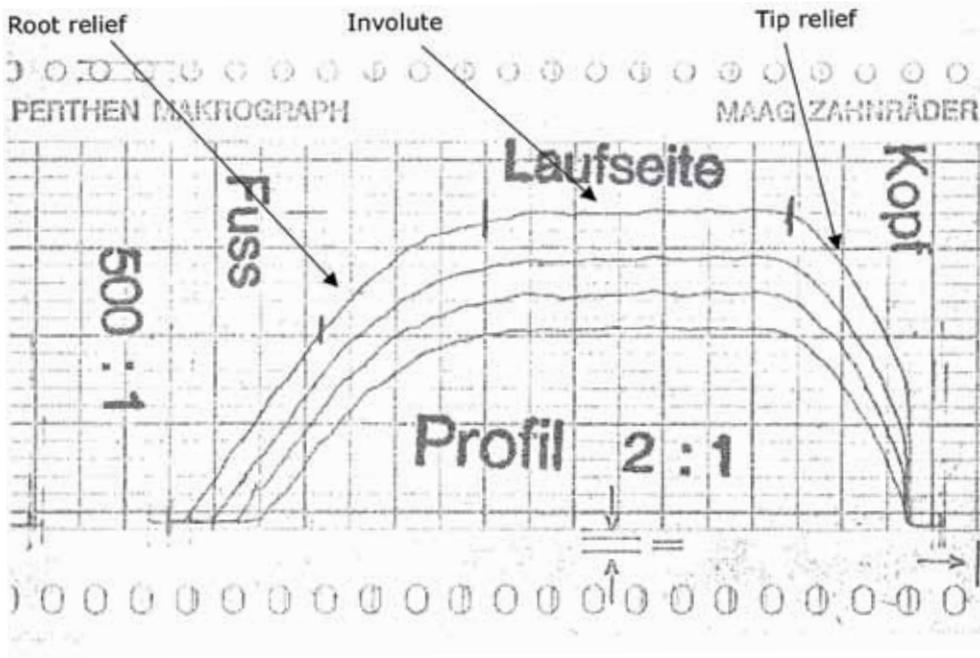
Figure 4. Profile measuring. Original measurement after the grinding process.

The tooth flanks of the sun pinion (first stage) were measured in order to provide a comparison between the toothing geometry now and the geometry of 37 years ago (Figure 4). The sun pinion showed a little wear of 0.02 – 0.03 mm, which causes no problems at all. It will be used for further operation (Figure 5). The sun pinion toothing is usually the most delicate part in view of wear and tear.

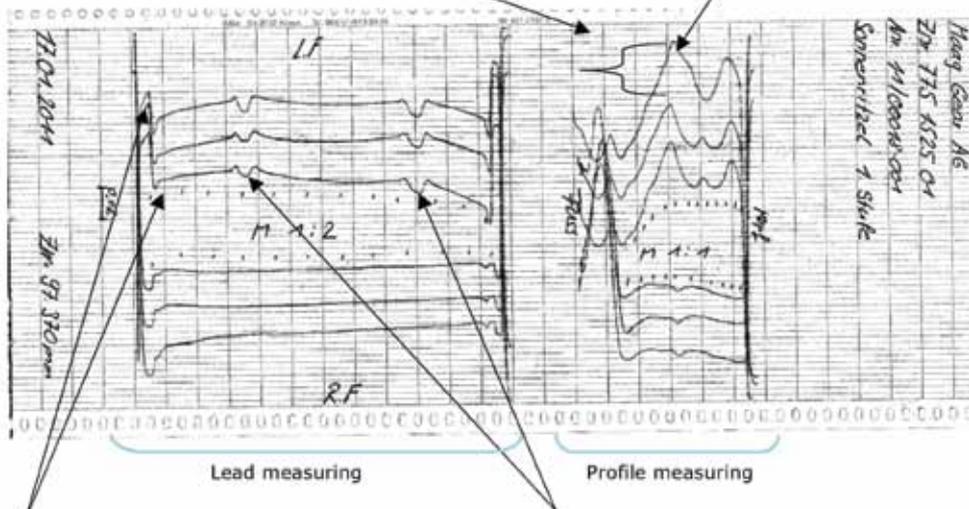
Little wear on tooth flank: 0.02-0.03 mm. Such wear after long operation time is not unusual.

Tooth pattern of planet wheel is recognisable. Also the location (0.008 mm) of oil injection is well visible at the diagram.

Figure 5. Lead and profile measuring after 37 years of operation.

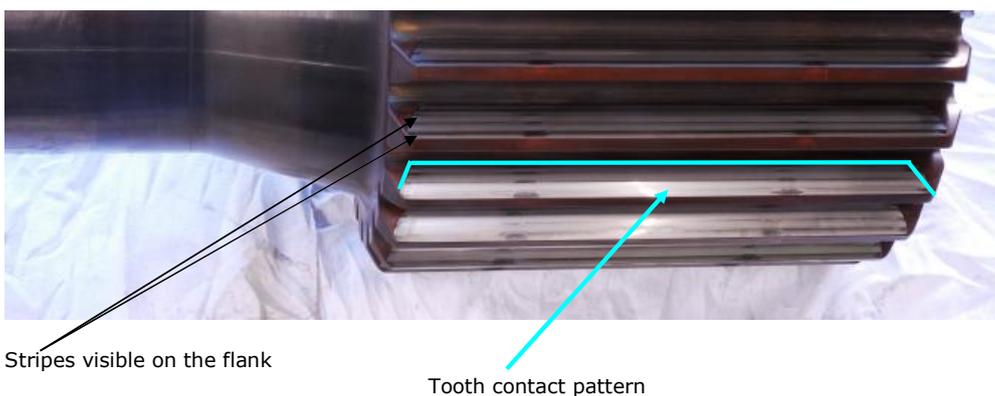
The stripes visible on the sun pinion teeth are caused by the mill's starting process (Figure 6). During start-up, the sun pinion aligns itself between three planet wheels, causing this effect. The tooth contact pattern of the respective gear covers the whole width, which proves flawless power transmission without any canting. All in all, a surprisingly satisfactory result.

Figure 6. Sun pinion toothing.
