# Screen media wear life aligned with Sag Mill maintenance schedule

With a plan in place to extend the regular shutdown schedule of their SAG Mill from a seven-week cycle to 16 weeks, one FLS customer knew in order to achieve their goal they also had to extend the wear life of their screen media. They turned to us for help.

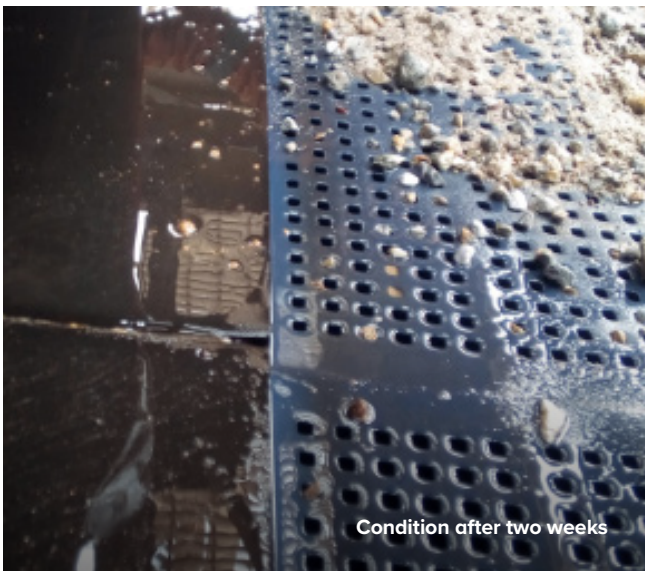
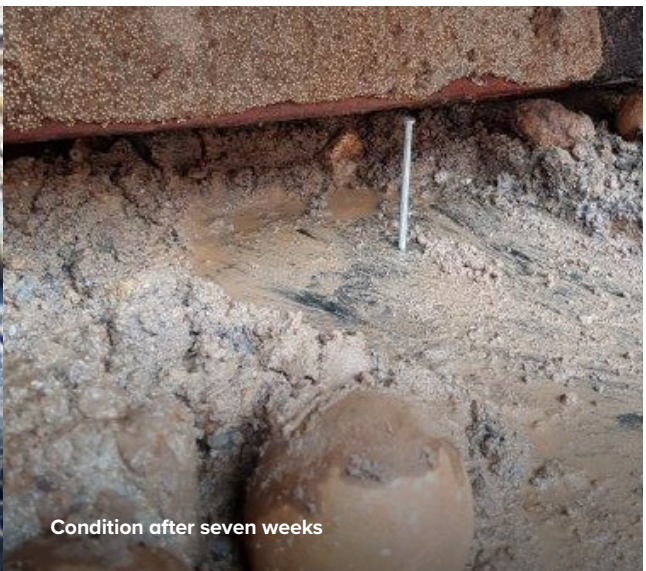
## Wear measurements at seven weeks

Position	Nail	Measurement	Thickness
1	120.6	97.4	23.2
2	120.6	97.7	22.9
3	120.6	97.4	23.2
4	120.6	95.6	25
5	120.6	97	23.6
6	120.6	98.5	22.1

The metallurgy team inspected the feed-end blank panels after two weeks of use and found the panels in very good condition. The panels were inspected again at seven weeks of use and the wear was considered very satisfactory.

Installed	Measurement	End of 16 weeks
Date	28/1/2018	17/3/2018	20/5/2018
Days in use	0	48	112
Thickness	35 mm	22.1 mm	5 mm*

\*With a measured wear rate of 0.27 mm per day as at March, 17 2018 the metallurgy team is confident the panels will last beyond the 16-week campaign.

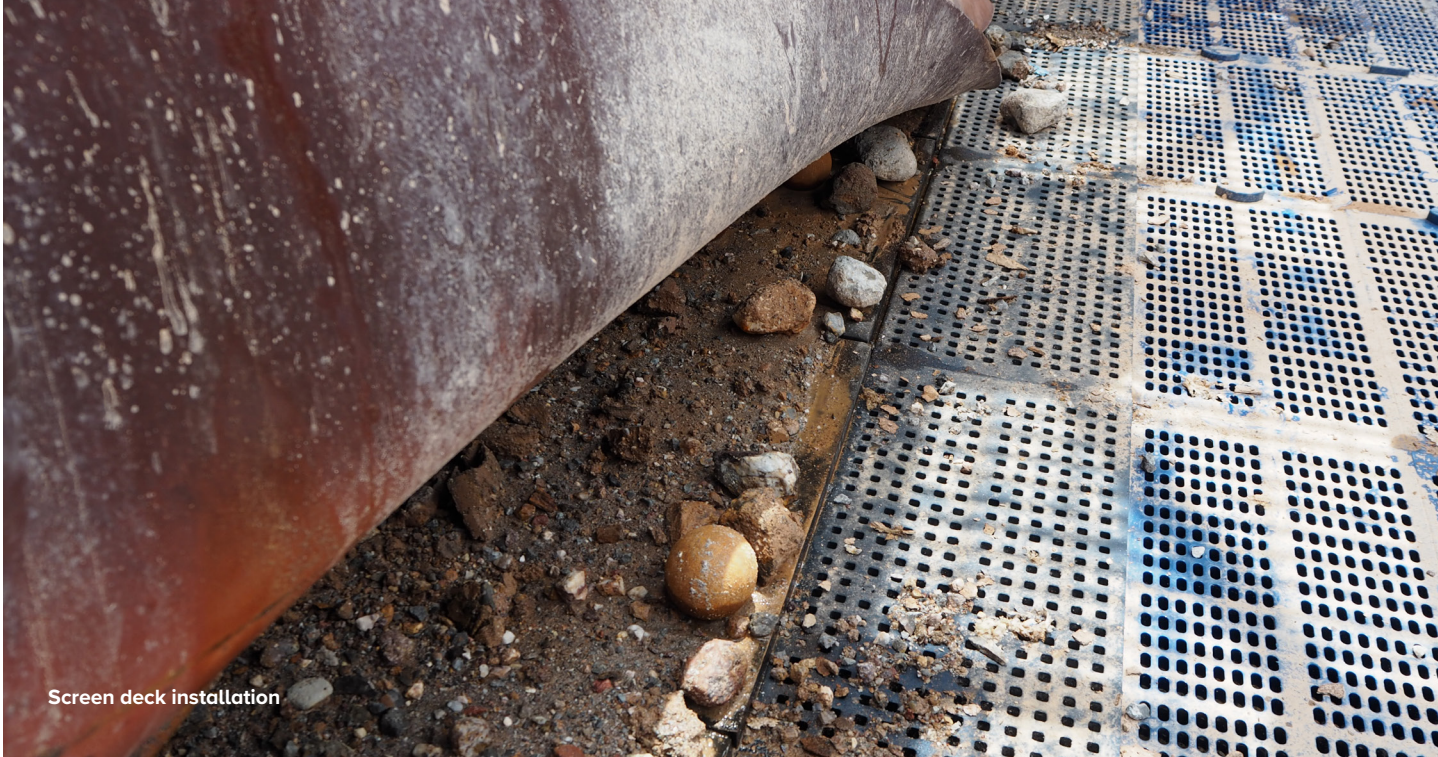
Screen deck installation

The screen media’s wear was reduced by combining a section of already installed LUDODECK P2 modular screen panels with removable rubber wear plates.

This process firstly involved increasing the panel’s thickness from 46 mm to 60 mm. Then, steel-backed rubber wear pads were bolted to the screen panels. This increased the overall thickness to 86 mm and meant the blank screen panel did not see any wear, allowing for reuse after every shutdown.

The solution did not change the original fixing method, therefore the panels were fitted by the mine crew on time and without any reported injuries. In addition, future replacements can be assembled offline and fitted quickly when required.
