St. Ives gold mine slashes maintenance costs with FerroCer® Impact wear panels

St. Ives extended the service cycle of their primary crusher significantly, saving downtime and maintenance costs. FerroCer® Impact wear panels have lasted more than four times longer than their rubber wear panels.

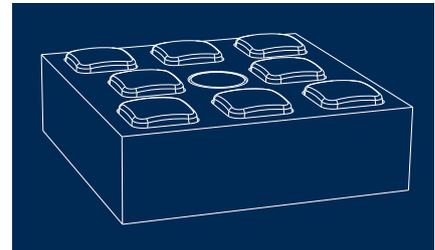
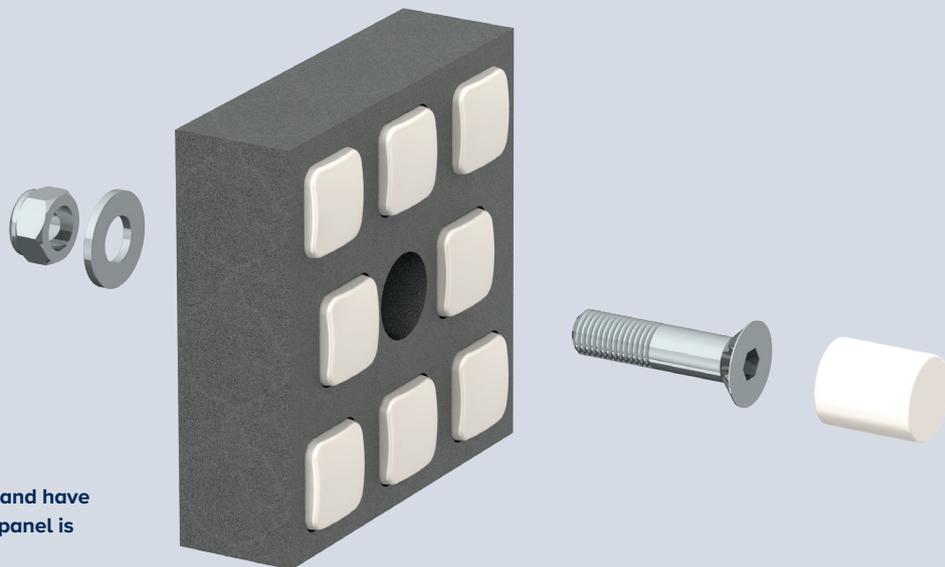
FerroCer Impact panels weigh only 5 kilo and have a compact and easy-to-handle size. Each panel is attached using a single countersunk bolt.

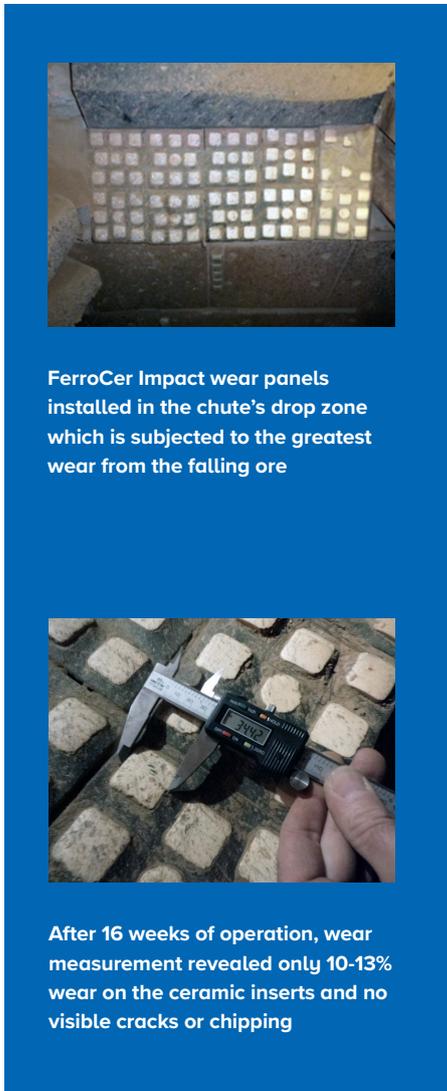
FerroCer Impact wear panels installed in the chute’s drop zone which is subjected to the greatest wear from the falling ore

After 16 weeks of operation, wear measurement revealed only 10-13% wear on the ceramic inserts and no visible cracks or chipping

FerroCer has lasted more than four times longer than the old rubber wear panels. That is taking St. Ives a long way towards reducing maintenance costs and achieving an uninterrupted production flow. Gary concludes, “I have to say, we’re pretty amazed.”
