# FLS trommel panels Screen media optimisation triples panel wear life

# Exceptional optimisation assistance and technical support

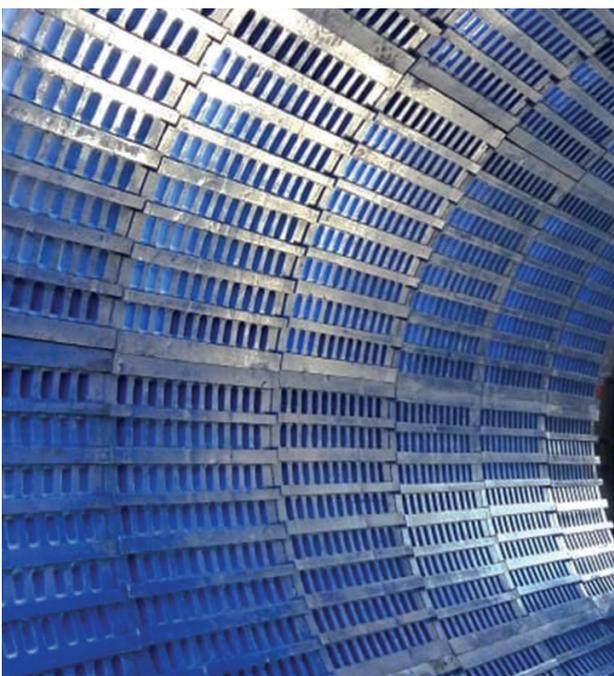
Installation of the new trommel screen media

Our FLS regional polyurethane shop in Santiago, Chile produced the new panels, adjusting their manufacturing as required for the new grade. The finished panels were shipped to the mine on schedule and were installed in June 2020. The six month trial began immediately after installation was complete.

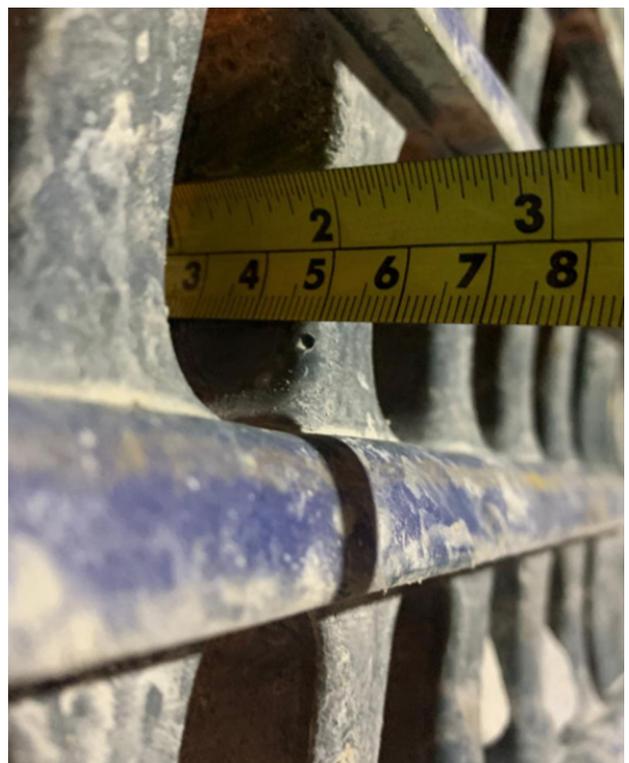
Frequent inspections and performance monitoring

During the trial, FLS partnered with the site for service and performed regular panel inspections. Expected wear patterns occurred during the trial, but none of the panels showed physical damage such as splitting, tearing, severe pegging or displacement. In December 2020, the trial was completed when it was determined that the first three rows of panels at the feed end finally reached the replacement threshold. There was minimal wear on the remaining five trommel rows.

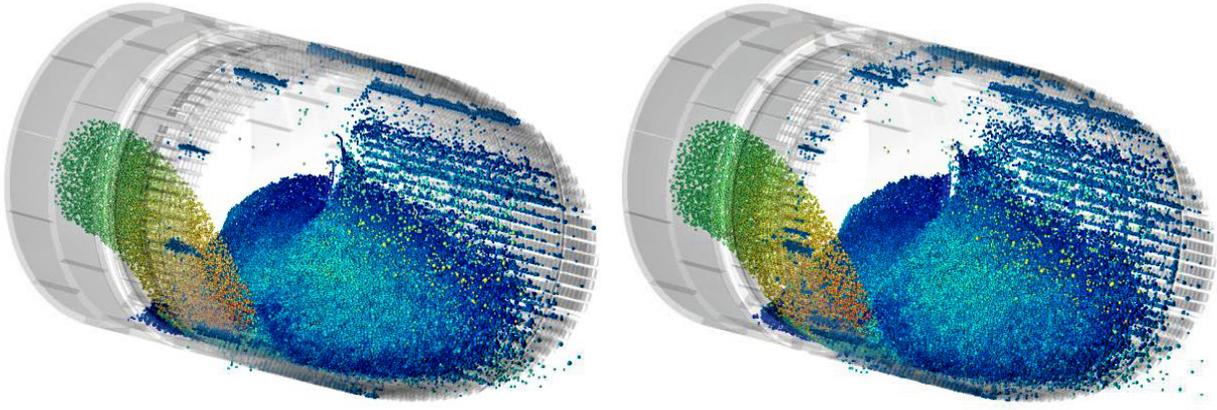
**Discrete element method (DEM) was used to simulate and confirm the effects of lower wear rates versus the degree of pegging/blinding as a part of our technical services to the client. The study validated the new design and pointed to potential improvements in throughput from reduced pegging/blinding.**

Using our DEM software, we can analyse your trommel's material distribution in order to optimise your screening media configuration.

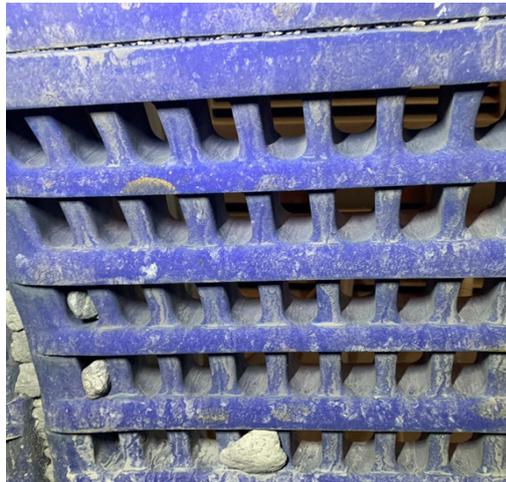
Screen panel at six months

- Previous rubber panels lasted two months before replacement
- Our high performance polyurethane screens lasted six months and were projected to last an additional six months in rows 3 through 8
- The panels were removed by customer after achieving the trial's goal of six months
- Reduced downtime with a corresponding increase in production, resulting in an estimated \$240,000 USD of additional copper recovery
- Reduced maintenance expenses
