# Extending cyclone underflow launder wear life - Australian iron ore mine

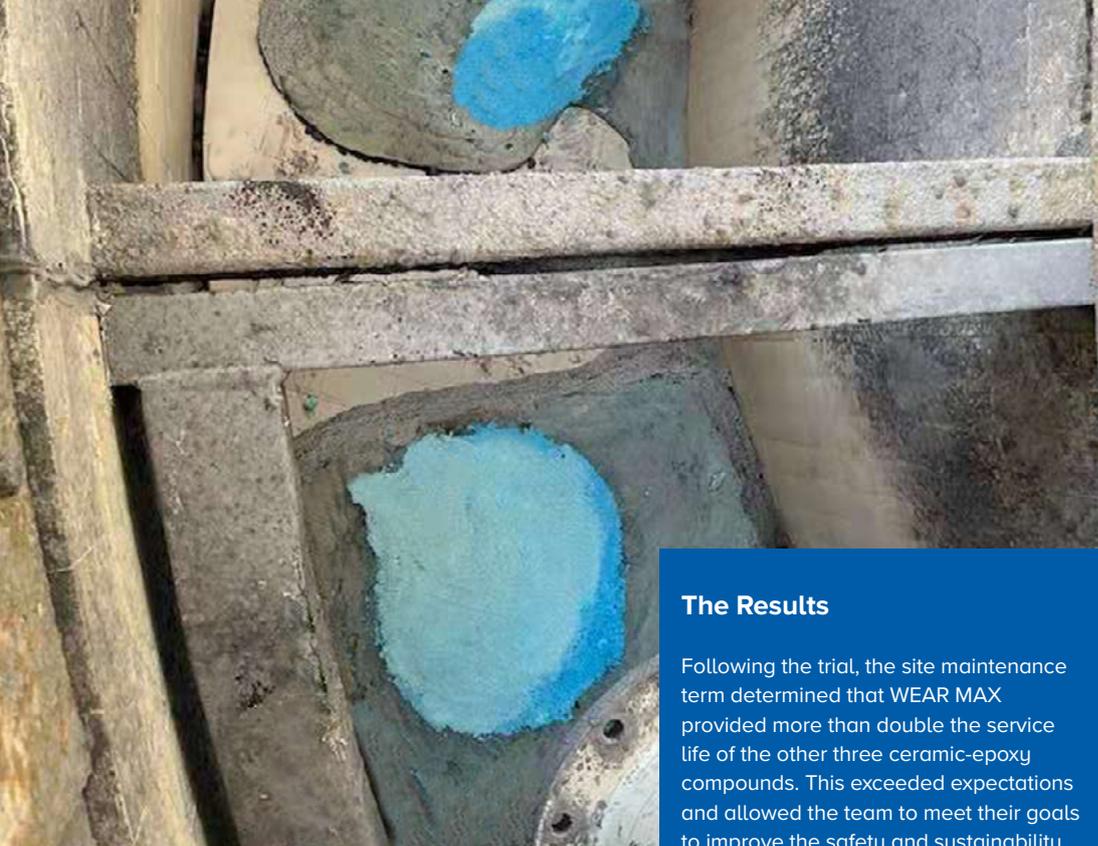
Cyclone Underflow Launder with Wear Max applied in high wear areas.

The site maintenance team applied the WEAR MAX coating to zones of high wear on the hydrocyclone launder, alongside the three other coatings that were commonly used for the application. The cyclone was then run for four weeks and removed from service to examine the four coatings.

At the end of the four-week trial period, WEAR MAX showed significantly less wear than its competitor products and could be returned to service. Two of the other coatings had worn away completely; the third was less than half as thick of the remaining WEAR MAX coating.
