# Kiln services – Resurfacing of rollers and tyres

# Improve mechanical stability and reduce costs

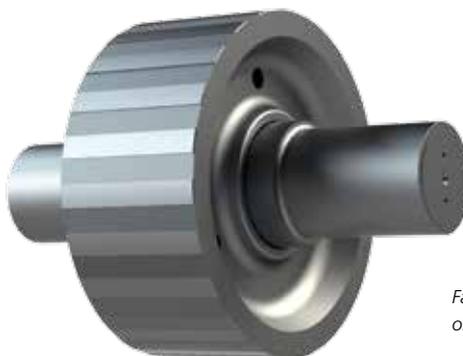
*Facet patterns on roller*

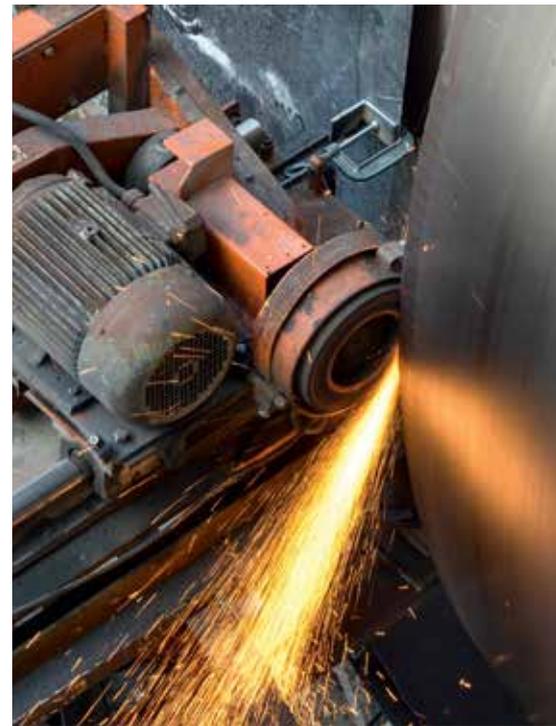
Thrust face grinding

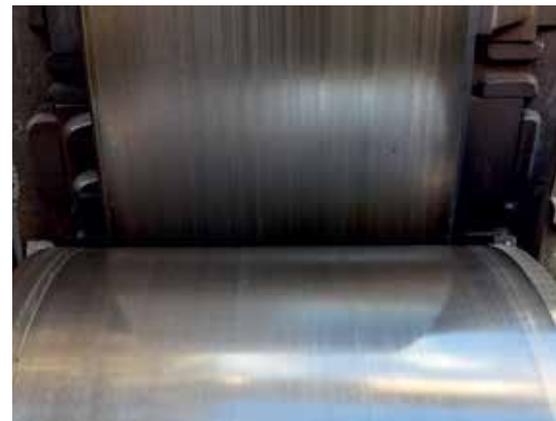
Surfaces after machining

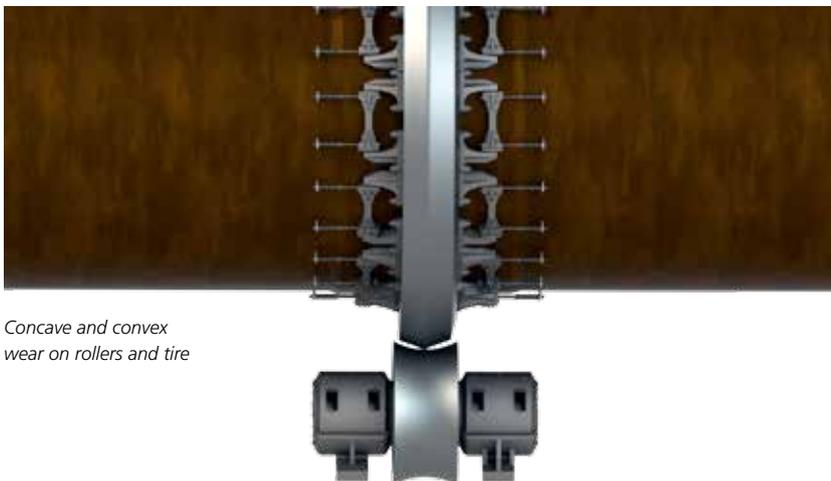
Concave and convex wear on rollers and tire

PROBLEM	DESCRIPTION	RESULT
Concave and convex wear	Results from normal skewing of the roller shafts - contact between tyre and support rollers decreases	Inability to control individual roller skew, high axial loading of bearings and potential bearing failure. Difficulty controlling axial positioning of the kiln/rotary equipment and increased power consumption
Rolled-over edges	Sometimes referred to as "mushrooming", this problem may have a variety of causes although badly skewed rollers are often to blame	Serious metal failure or entire cracked tyre faces
Taper wear	Conical wear, or radial taper, occurs when the diameter of the tyre and roller decreases faster on one side of the face	Increased drive component wear and kiln drive amperages leading to higher kiln operating costs
Timing marks	Horizontal or diagonal "wash board" patterns are imprinted on the rolling surfaces over a period of time by a poorly aligned gear and pinion	Pounding action quickly leads to mechanical failure
