Redesigned carbon retention screen delivers a multitude of benefits

A Canadian gold mine was looking for a solution to recurring shutdowns and high costs from the frequent replacement of its worn-out carbon retention screens. FLS not only developed a new screen, but also provided process recommendations that led to almost 300% greater wear life, together with improvements in productivity and worker safety.

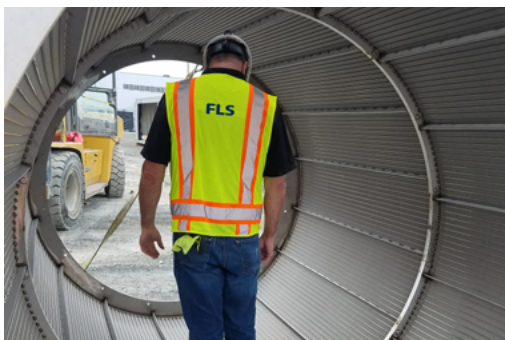
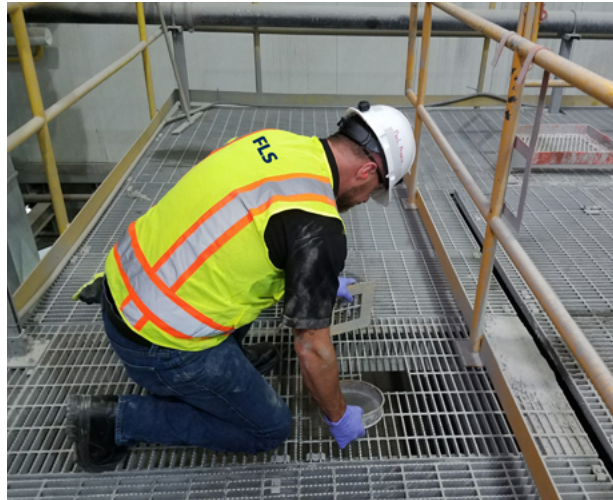
- Nearly triple the screen wear life
- 6% larger overall open area on the screen
- Increased production and profitability
- Increased safety
- 50% reduction in screen waste

After visiting the site to evaluate the screening process – studying both the material and the screen wear patterns – our technicians recommended a trial with a new screen wire geometry that increased the screen’s overall open area from 23% to 26%. The first trial was a success, with a 10-week increase in screen life from 13 weeks to 23 weeks, and mine management was pleased to have exceeded their goals. Our technicians, however, felt the screen life could be further improved.

After performing a finite element analysis (FEA) on the new screen, reviewing its vibration and other test results, our FLS technicians recommended another design that had the same wire geometry, but that would provide 29% overall open area. The mine agreed to a second trial with the new screen design, which resulted in an increased screen wear life of an additional six weeks, for 29 total weeks.
